Town of Rowley

Bridge Inventory Evaluation

JUNE 2019

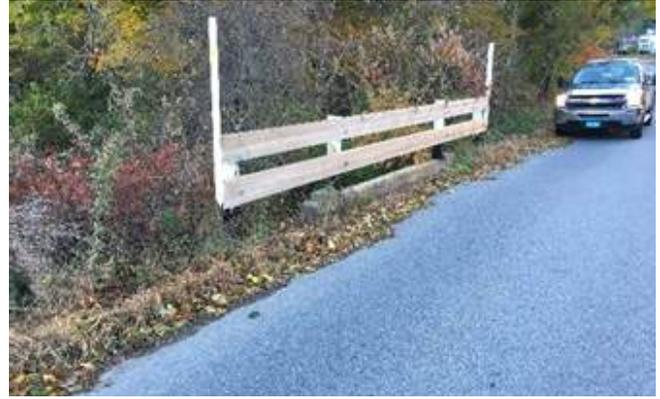
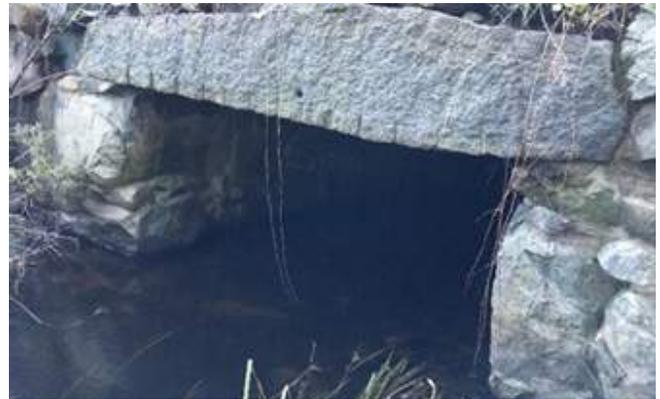
10. Cross Street (12)

BRIDGE TYPE	Slab with concrete/granite
WEARING SURFACE	Asphalt
RAILING TYPE	
UPSTREAM	Wire
DOWNSTREAM	Wood
OVERALL CONDITION	7
NOTES:	Masonry abutment with granite slab. Last 5' at downstream end is concrete abutments and slab.
IMMEDIATE NEEDS

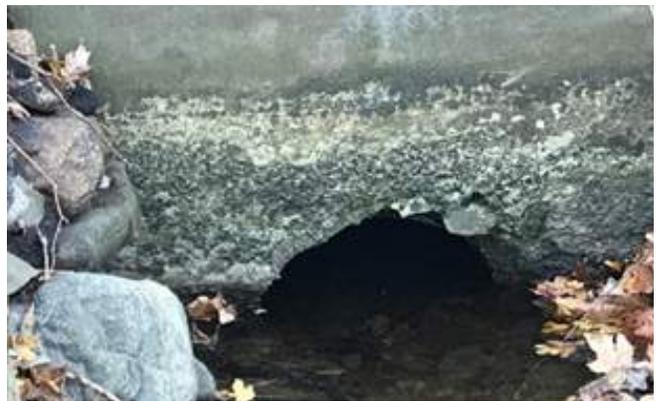
20. Haverhill Street (89)

BRIDGE TYPE	Single culvert with metal pipe (downstream) and plastic pipe (upstream)
WEARING SURFACE	Asphalt
RAILING TYPE	
UPSTREAM	Metal guardrail
DOWNSTREAM	None
OVERALL CONDITION	5
NOTES:	Upstream headwall in fair condition with some spalling. Roadway drains directly over headwall. Downstream headwall has minor spalling.
IMMEDIATE NEEDS	Repair upstream headwall

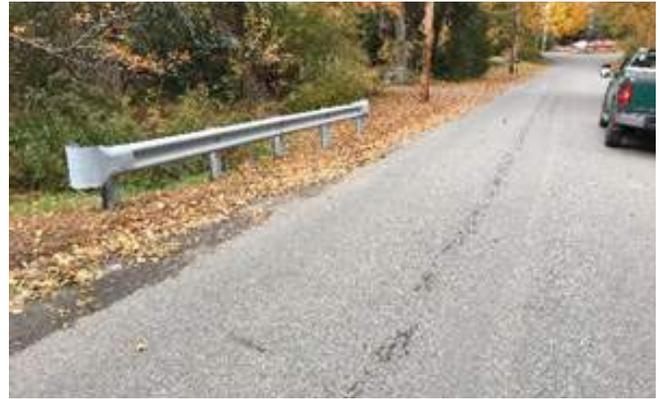
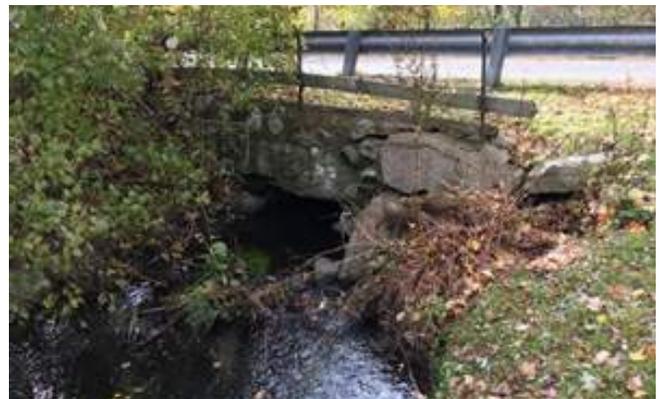
28. Independent Street over Ox Pasture Brook (40)

BRIDGE TYPE	Opened bottom arch
WEARING SURFACE	Asphalt
RAILING TYPE	
UPSTREAM	Guardrail
DOWNSTREAM	Guardrail
OVERALL CONDITION	4

NOTES: Erosion appears behind headwall and wing at inlet and outlet. Partial collapse of upstream wingwalls. Un-grouted masonry. Fills up during heavy rain but no overtopping.

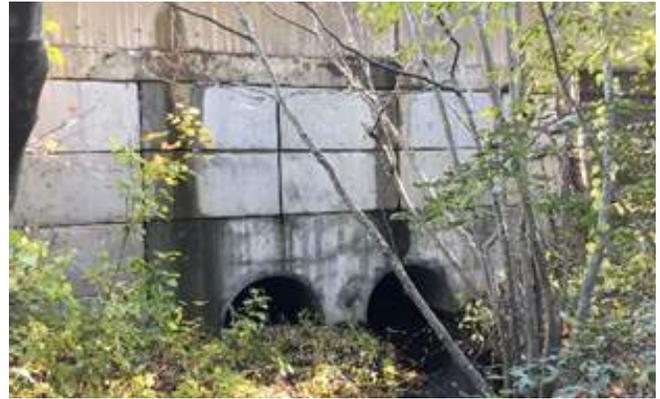
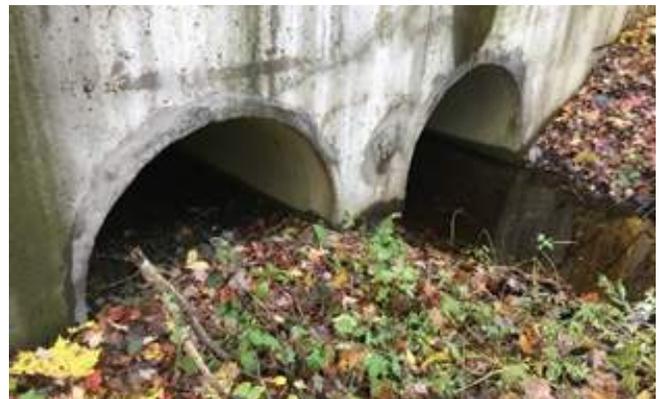
36. Turcotte Memorial Drive (8)

BRIDGE TYPE	Double culvert with concrete pipe
WEARING SURFACE	Asphalt
RAILING TYPE	
UPSTREAM	Wood guardrail
DOWNSTREAM	Wood guardrail
OVERALL CONDITION	8
NOTES:	North pipe is blocked with debris.
IMMEDIATE NEEDS

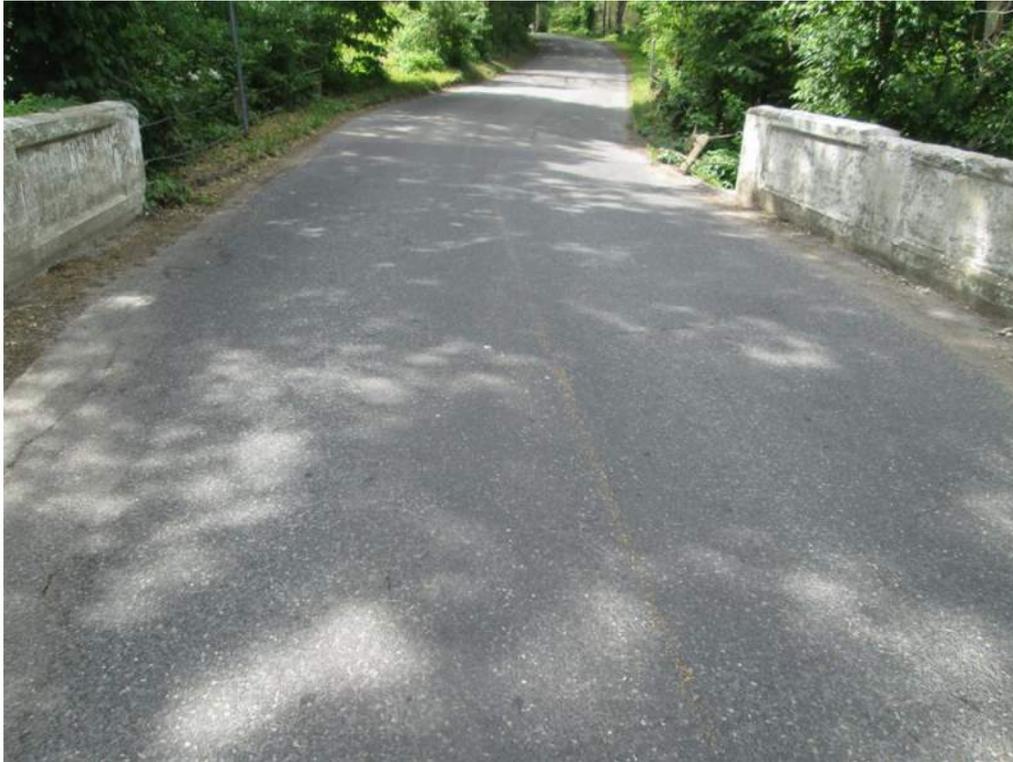
Photo 1: Bridge Wearing Surface Transverse Cracking with Tire Wear

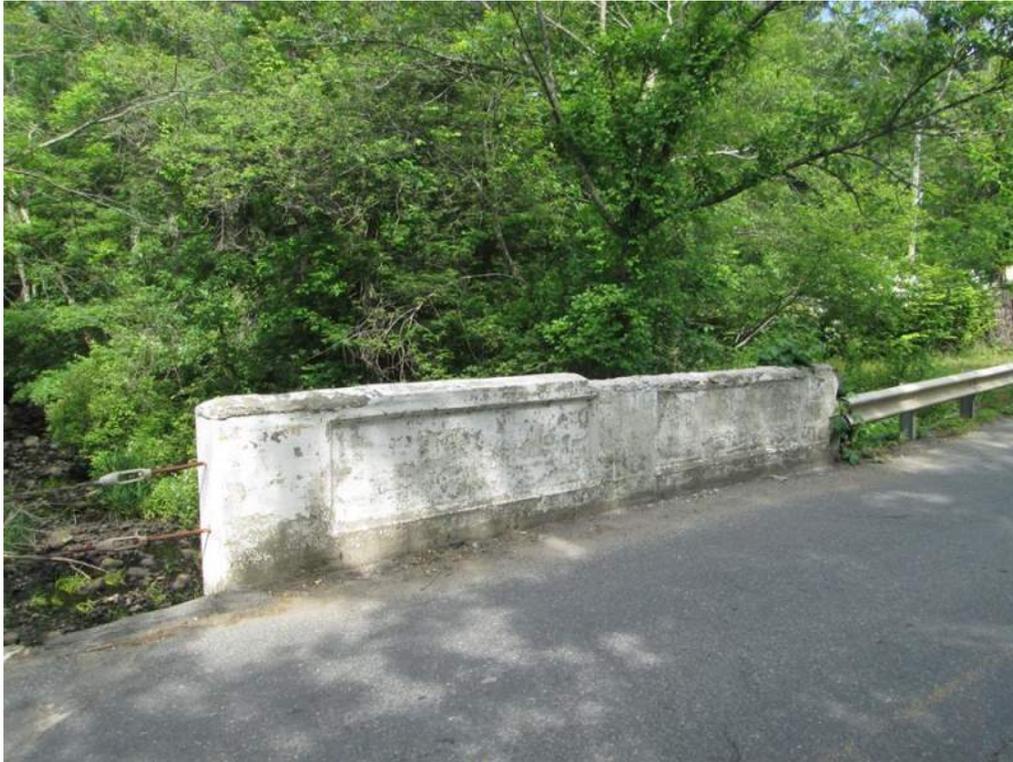
Photo 3: West Bridge Rail (Parapet) with Northwest Top Concrete Section Spalled

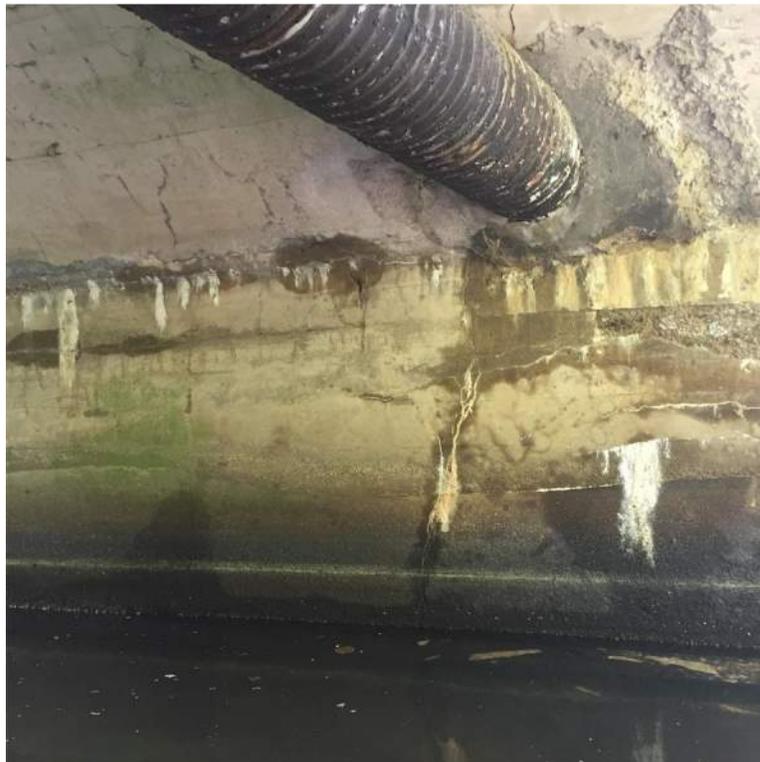
Photo 4: South Spring Line Utility Patch Spall with Crack

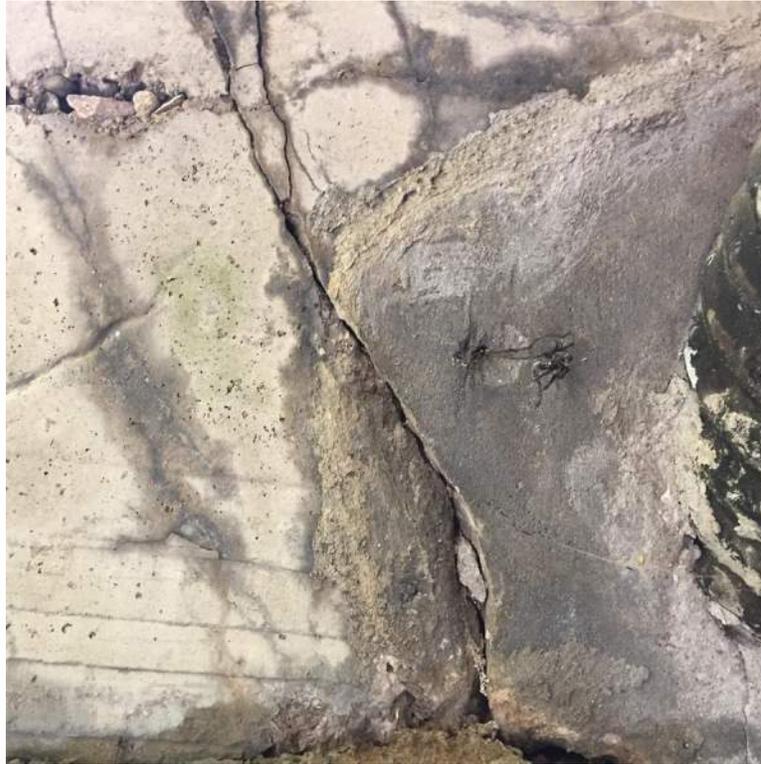
Photo 5: North Spring Line Utility Patch Spall with Crack Propagating into Arch

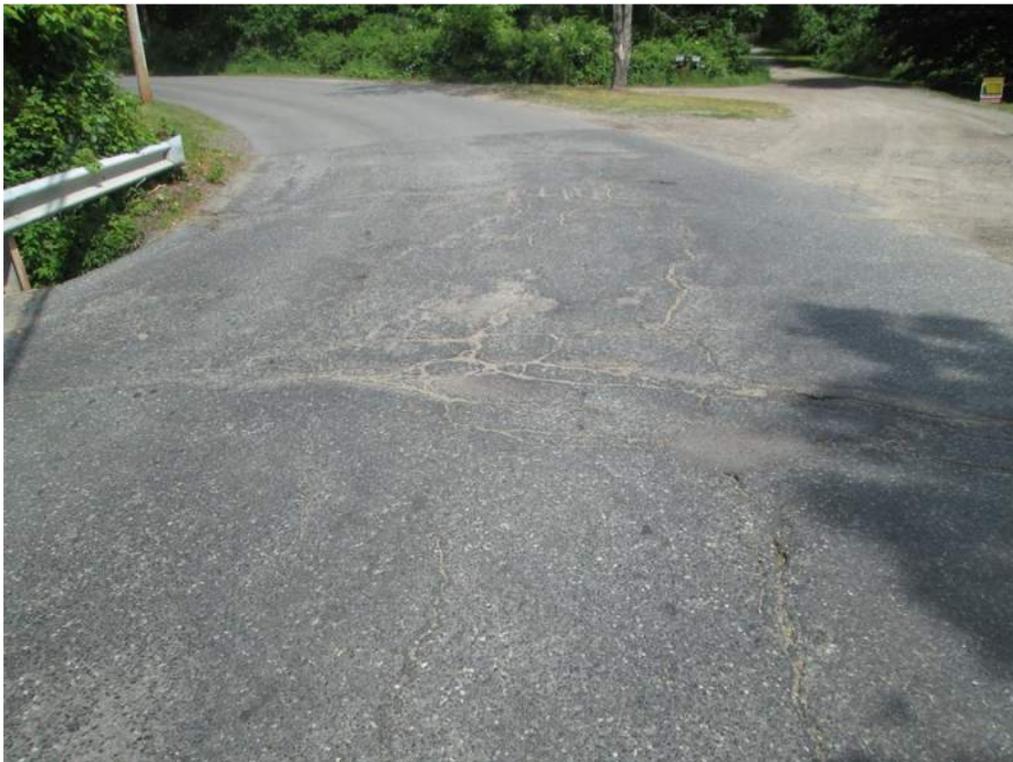
Photo 6: North Approach Pavement with Map Cracking

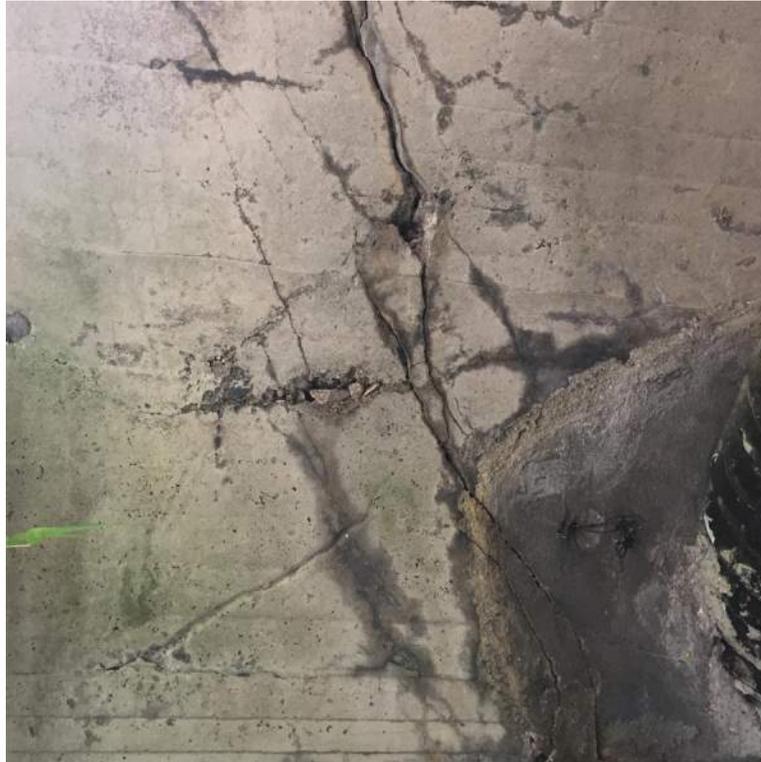
Photo 7: Northwest Arch/Arch Ring Crack Propagating from Utility Patch

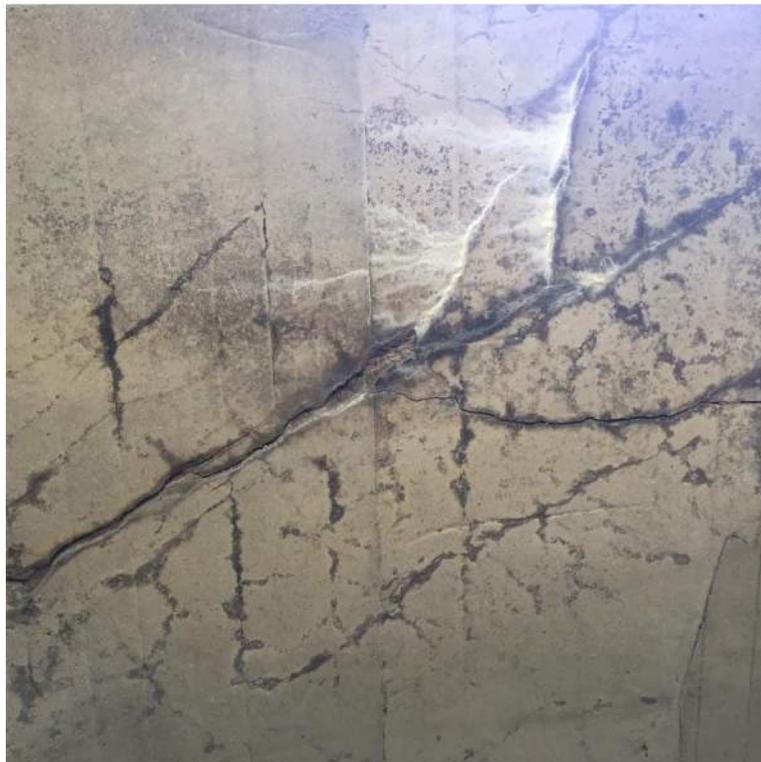
Photo 8: West Arch Underside Crack from Utility Patch to Utility Patch with Cracks Propagating off Main Crack

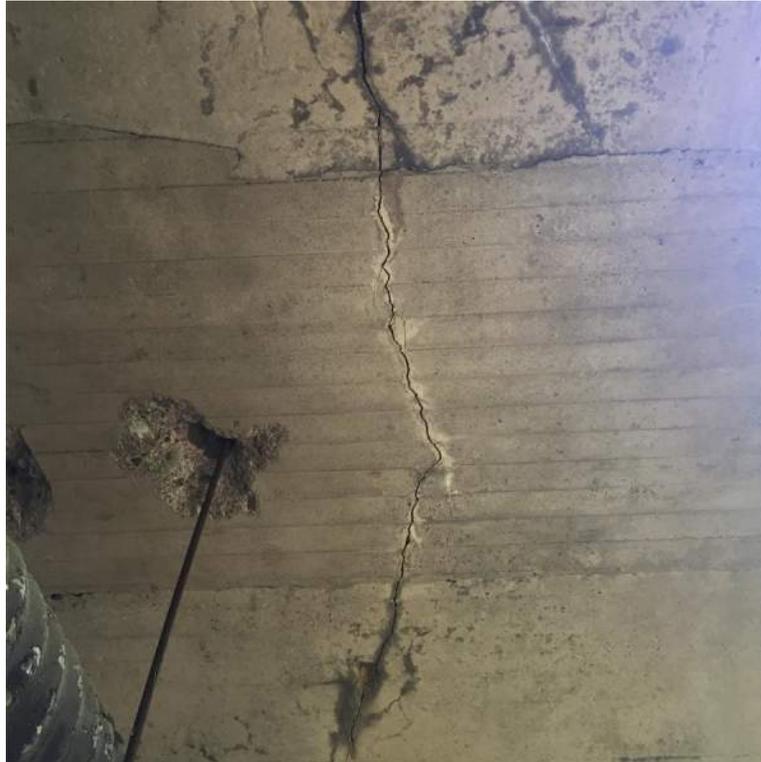
Photo 9: Typical Utility Support Embedded in Arch with Spall

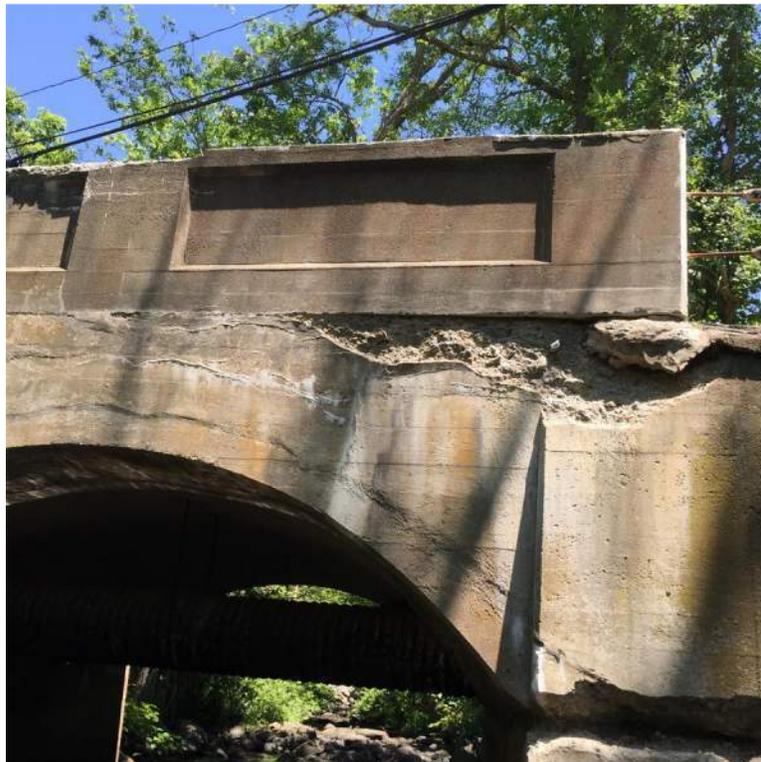
Photo 10: Southwest Spandrel Wall Spall Under Parapet Extending into Southwest Wingwall

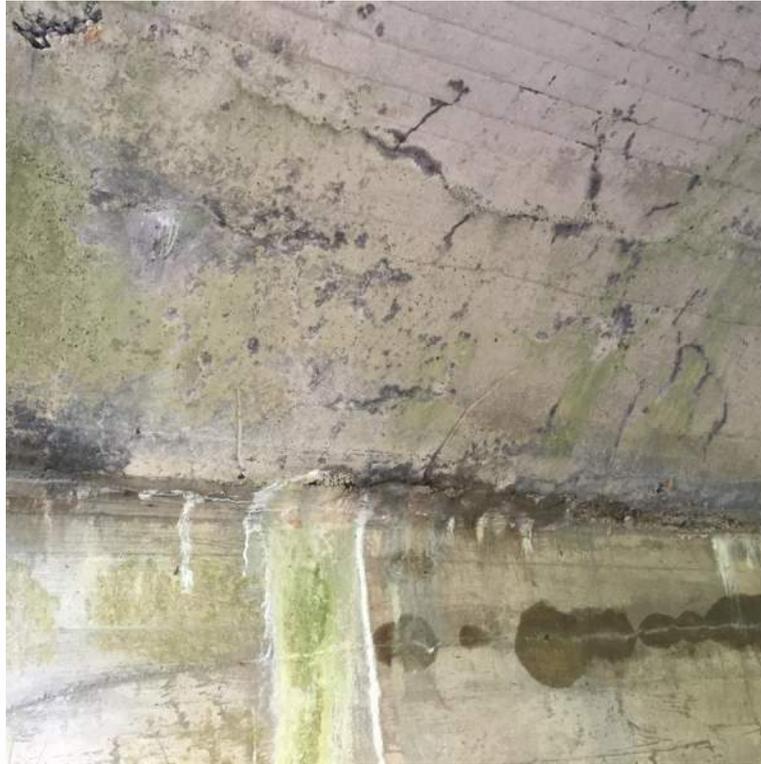
Photo 11: South Spring Line near East Fascia Spring Line Spall with Active Leakage and Efflorescence

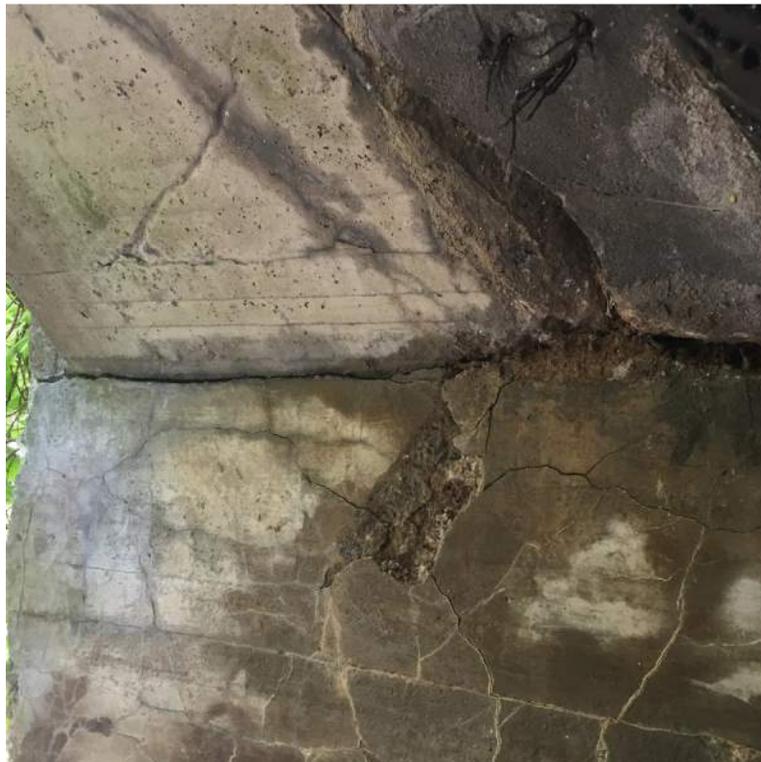
Photo 12: North Spring Line Near West Fascia Crack/Spall with Active Leakage

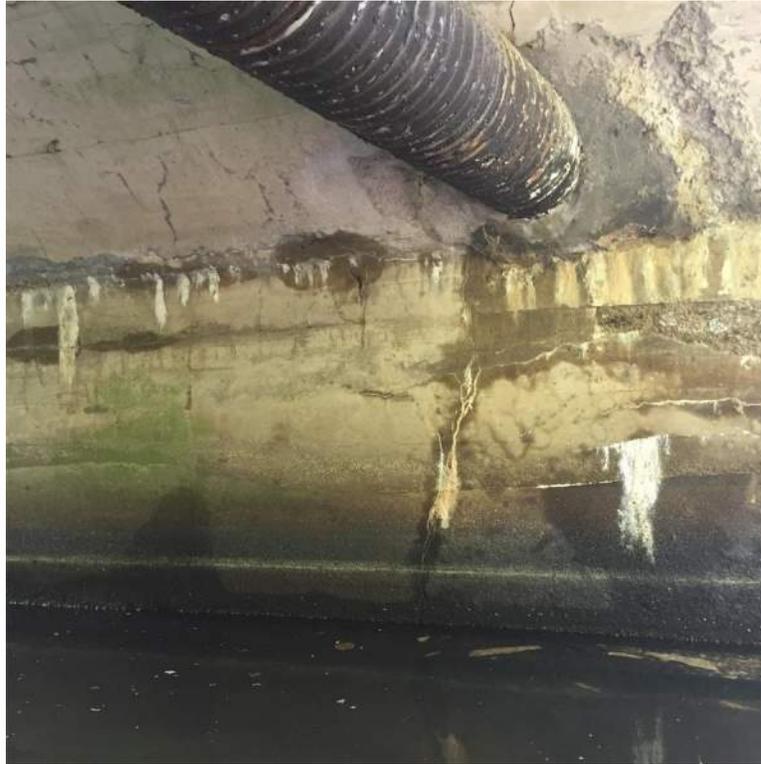
Photo 13: Southwest Breastwall Map Cracking with Efflorescence and Active Leakage

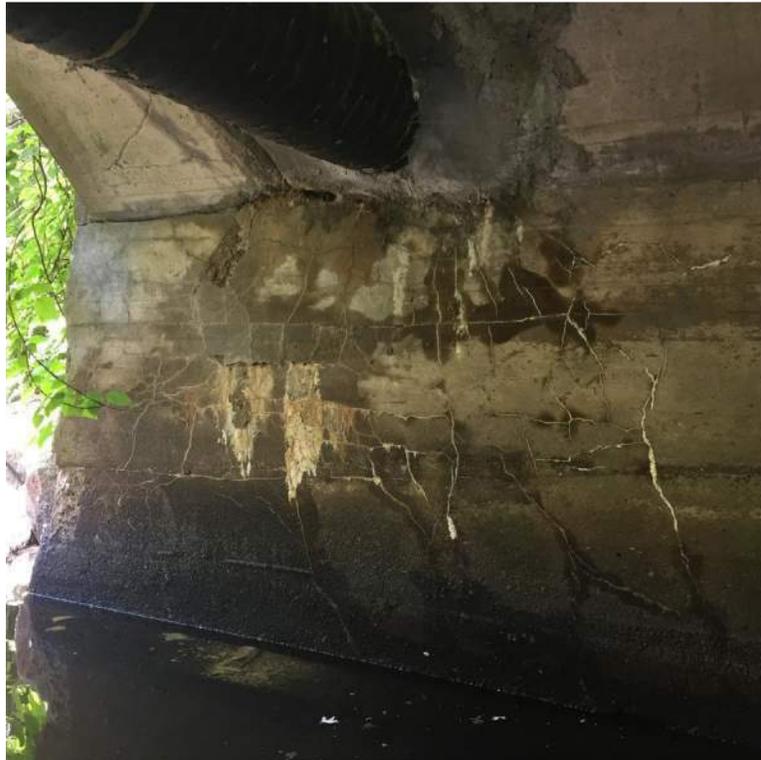
Photo 14: Northwest Breastwall Map Cracking

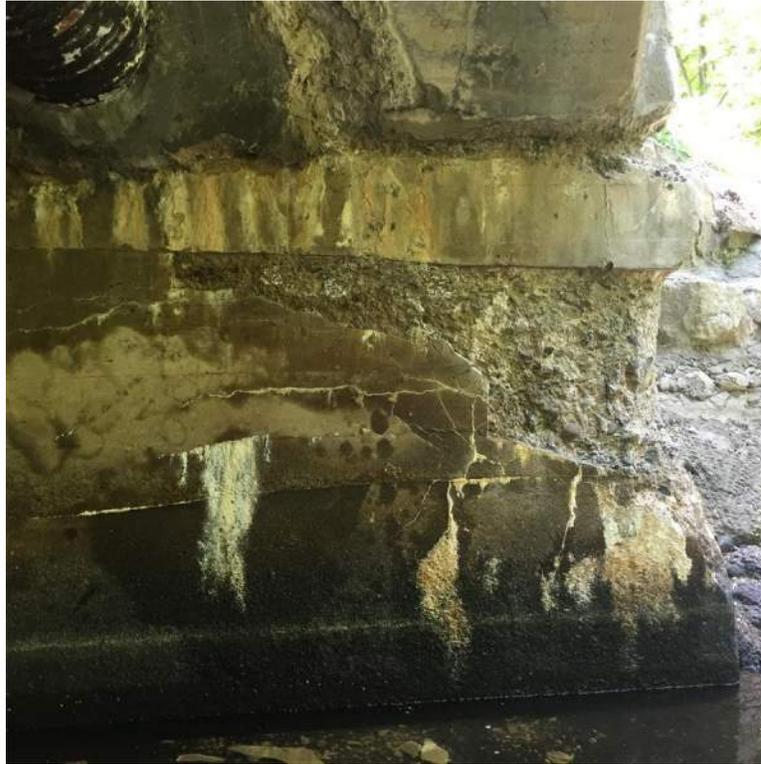
Photo 15: South Breastwall at West Fascia Spalled Concrete that Extends into Southwest Wingwall

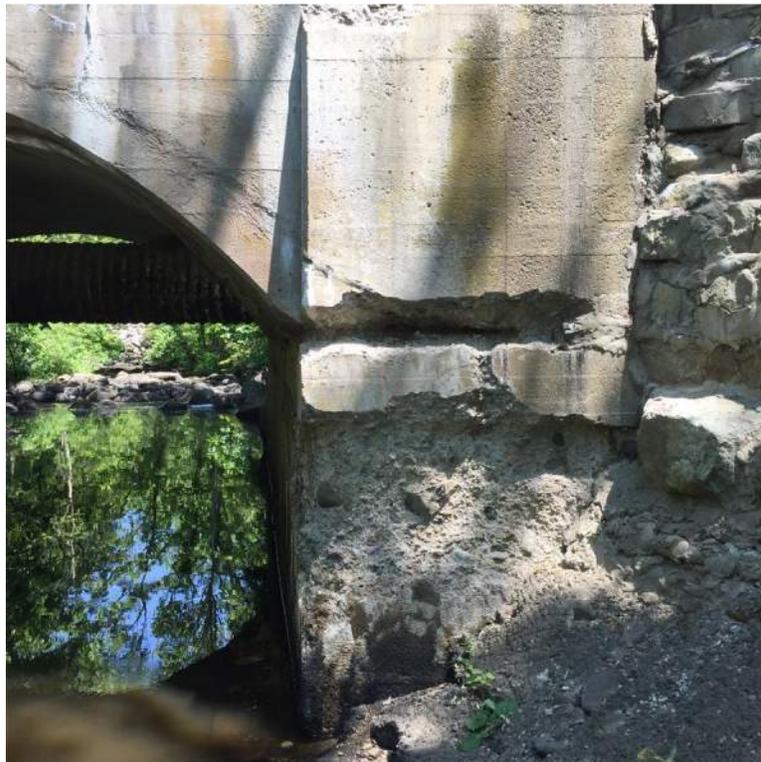
Photo 16: Southwest Wingwall Spall

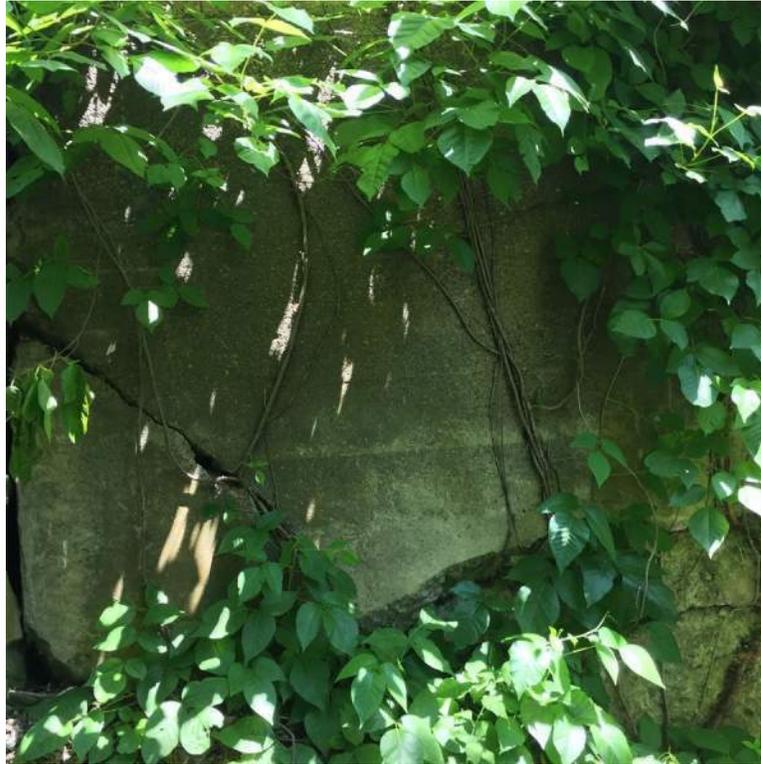
Photo 17: Northwest Wingwall Cracked/Broken Section

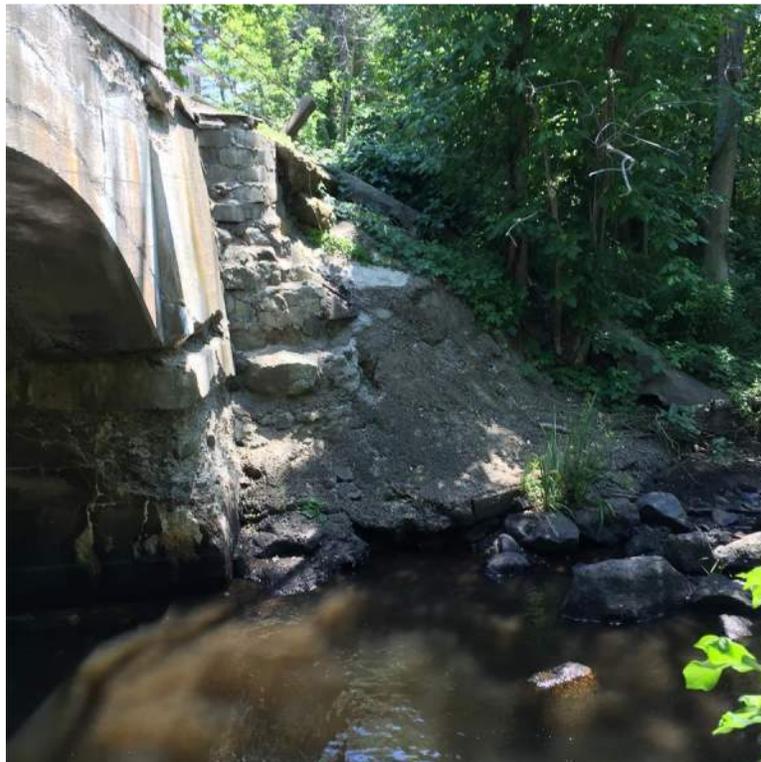
Photo 18: Southwest Embankment Slope Paving that is Cracked/Deteriorated

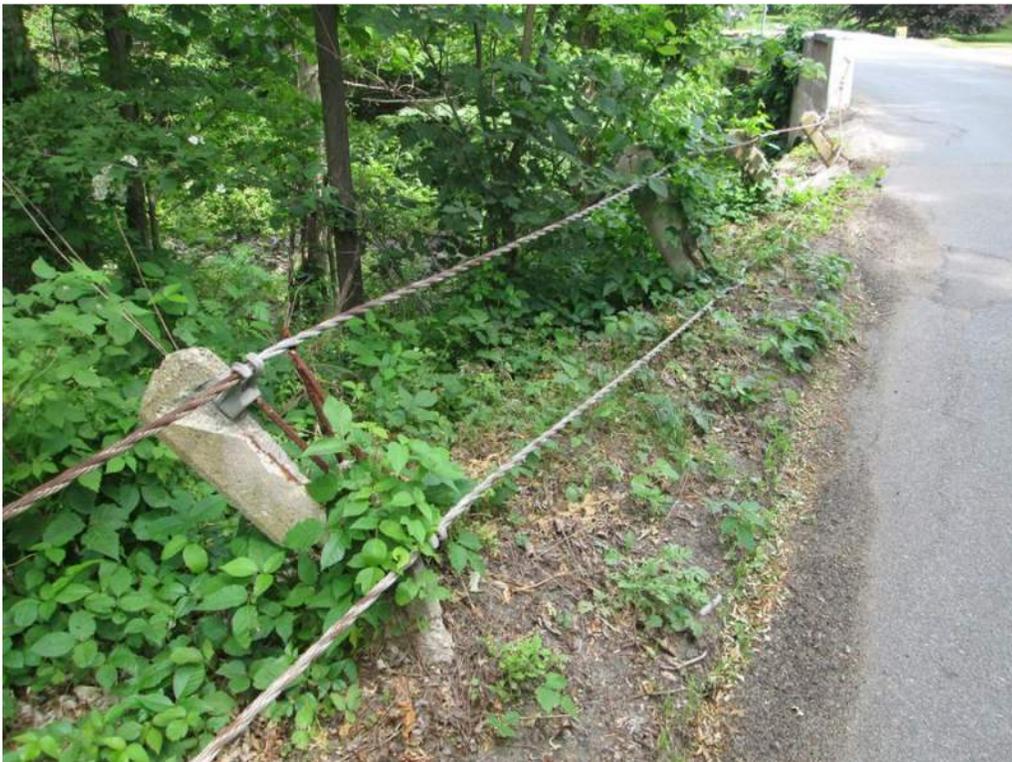
Photo 22: Southwest Approach Two Wire Cable Steel Rail and Concrete Posts Bent/Broken with up to 100% Loss of Section

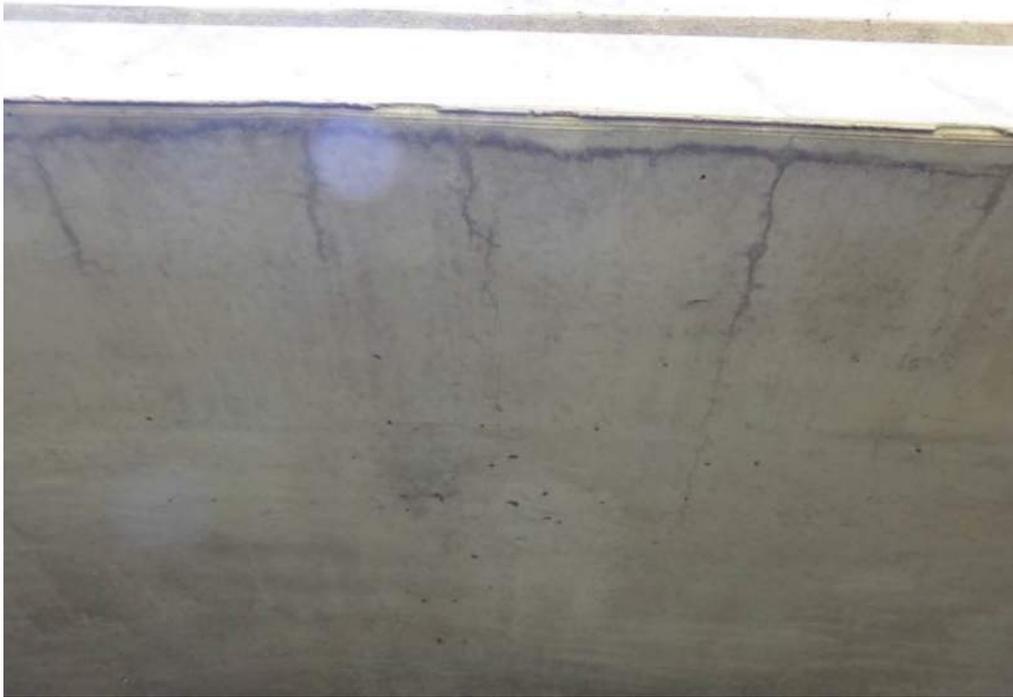
Photo 1: Cracking at Span 1 Section 4 intrados. (Typical throughout both spans)

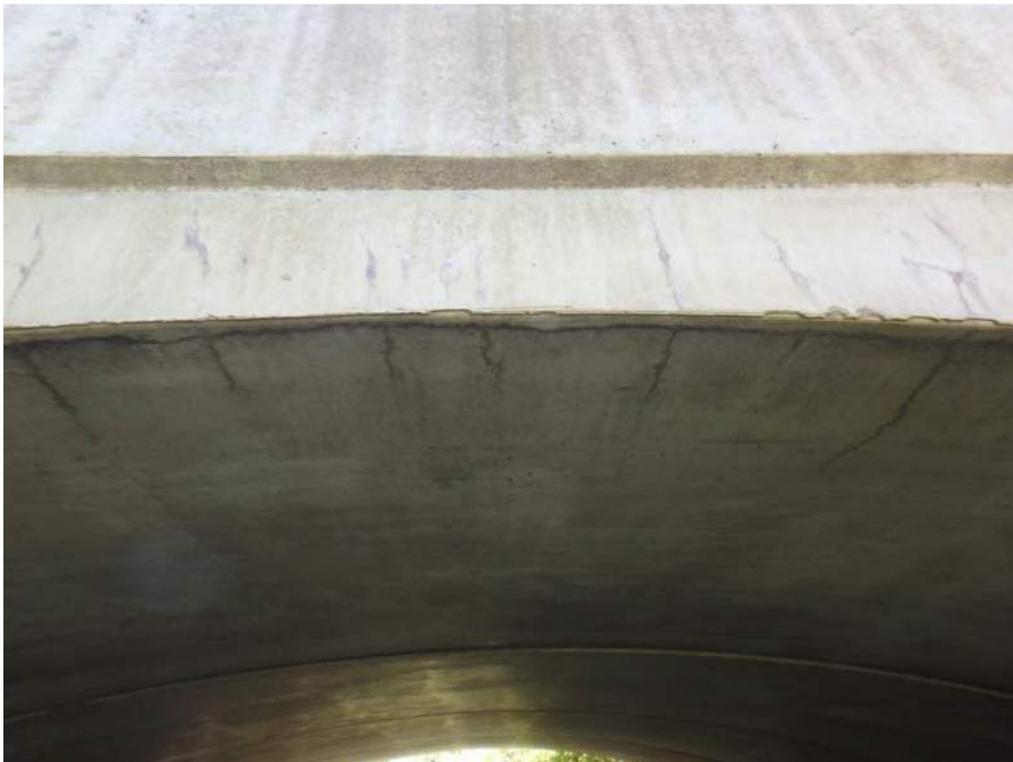
Photo 2: Cracking at north face of Span 1 Section 4 (typical)

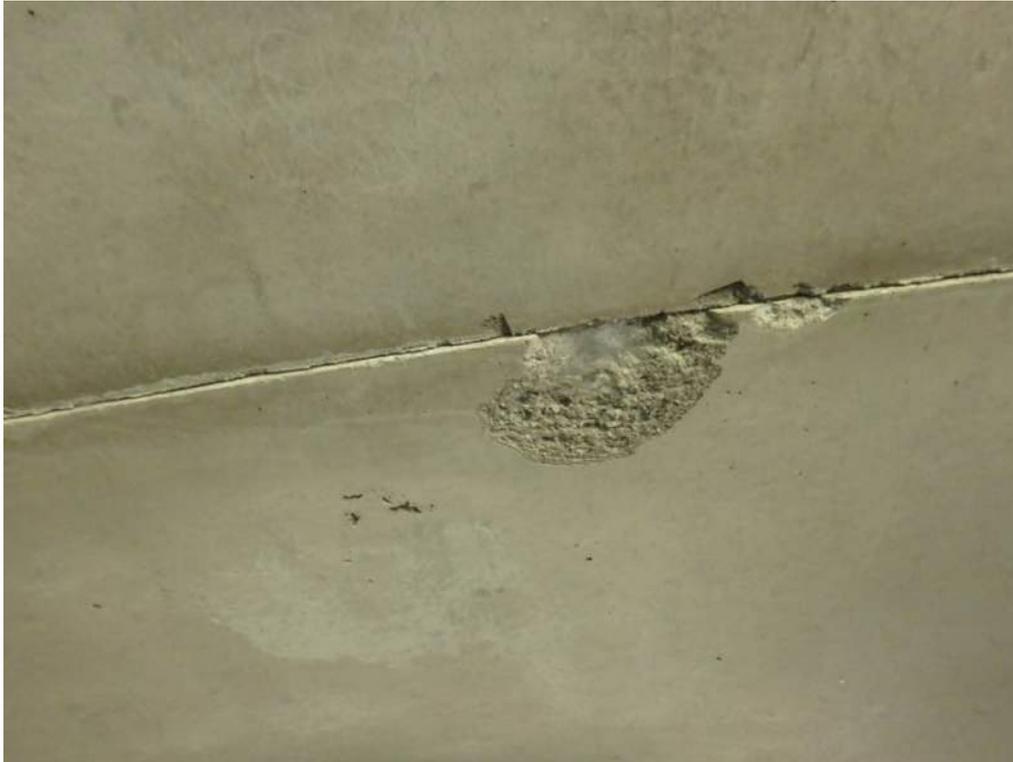
Photo 3: Spall at Span 1 Section 3: 8" Diameter x 1" deep.

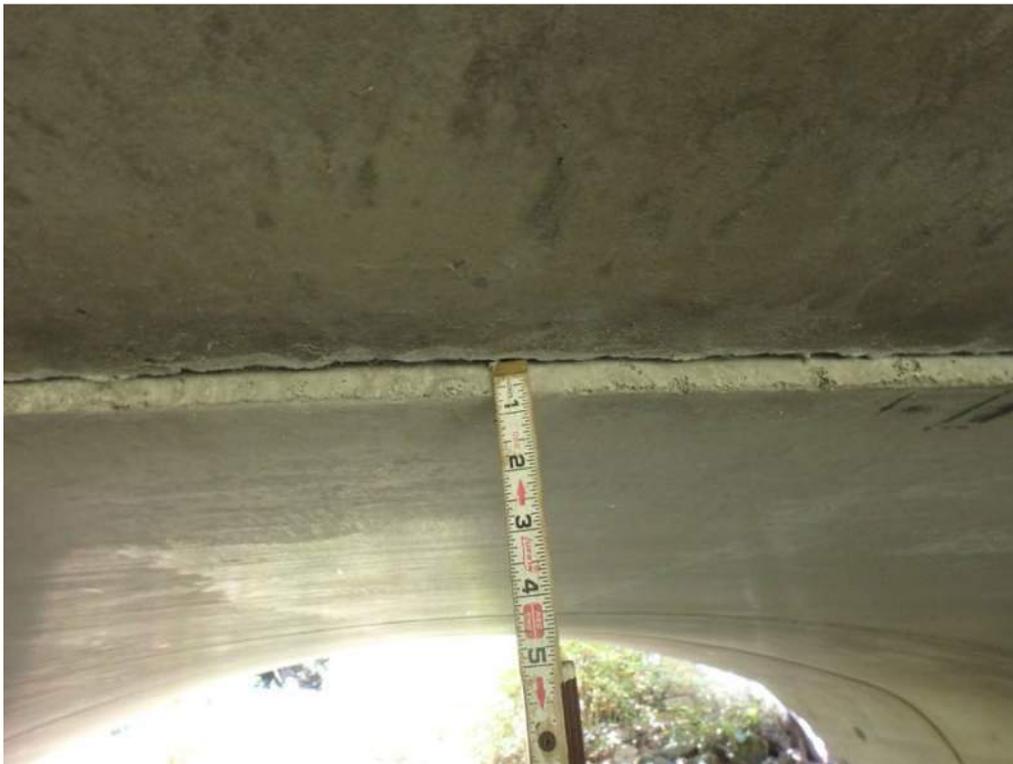
Photo 4: Span 1, Section 3/Section 4 interface: Section 3 is 3/4" lower than Section 4 at crown.

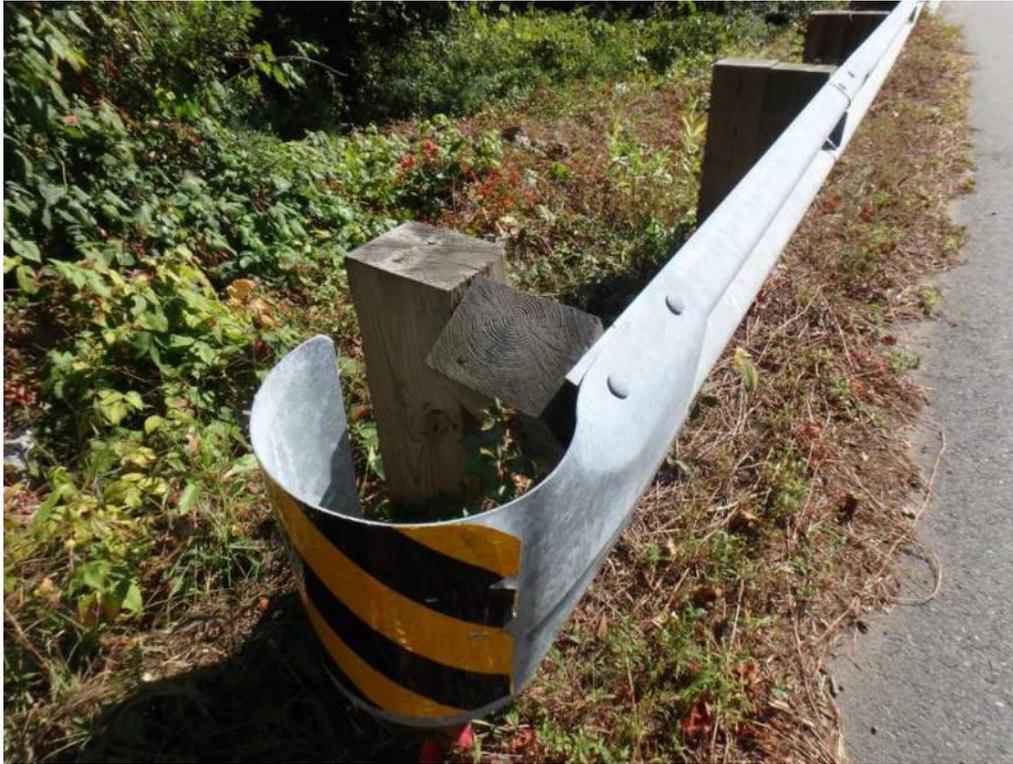
Photo 7: Northwest guardrail end with loose misaligned spacer block.

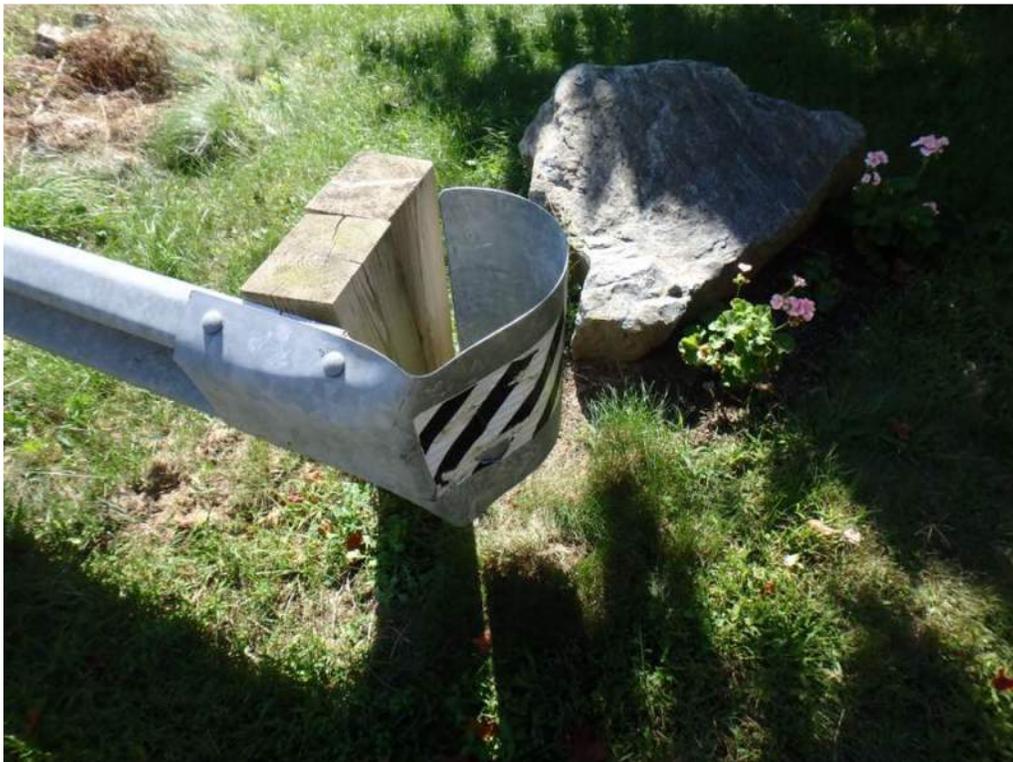
Photo 8: Southwest boxing glove end treatment has minor damage.

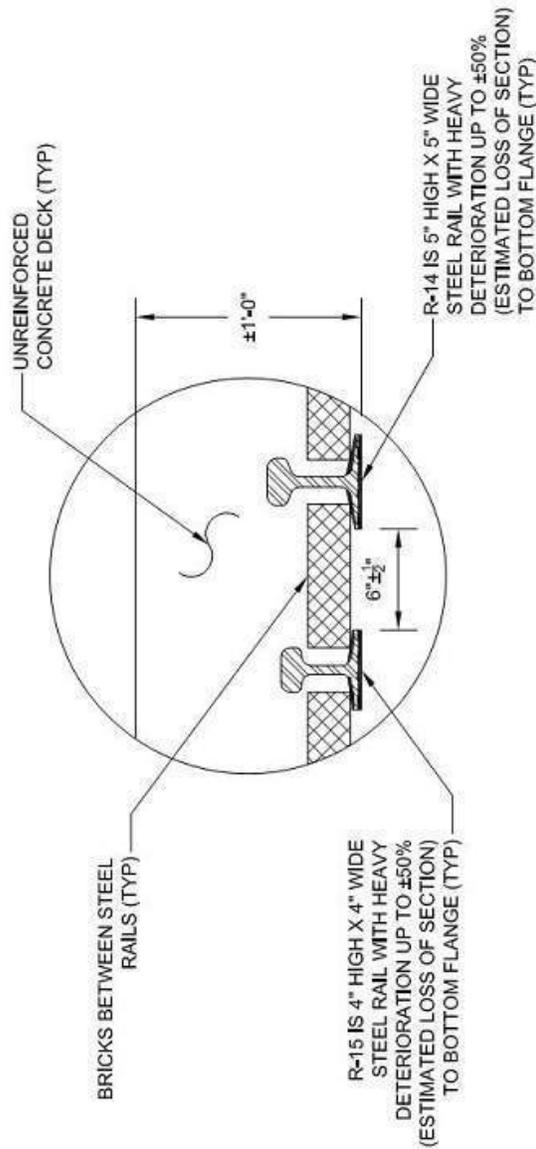
WIDESPREAD HEAVY DETEIORATION WAS OBSERVED AT THE BOTTOM OF RAIL. THE BRICKS BETWEEN RAILS PREVENTED ACCESS TO THE TOP OF THE BOTTOM FLANGE, WEBS AND TOP OF RAILS. LOSSES TO THE BOTTOM FLANGE WAS NOT FIELD MEASURED, BUT WAS BASED ON A VISUAL ASSESSMENT DUE TO THE INABILITY TO ACCURATELY MEASURE THE LOSSES.

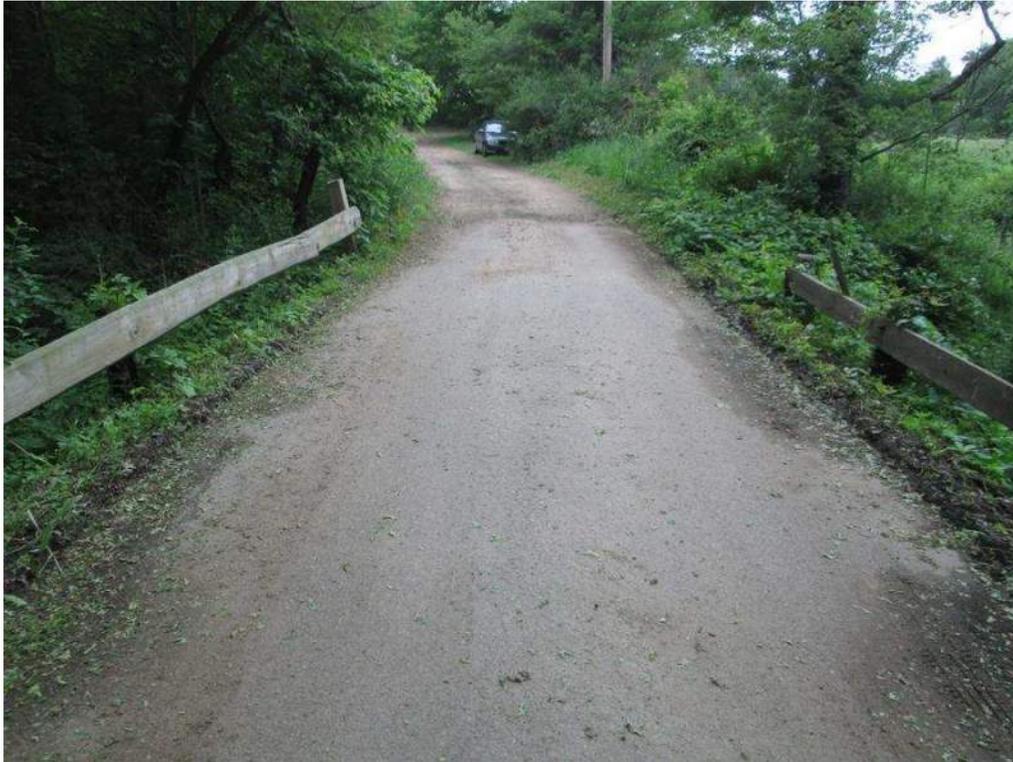
Photo 1: Typical Bridge Wearing Surface Tire Wear

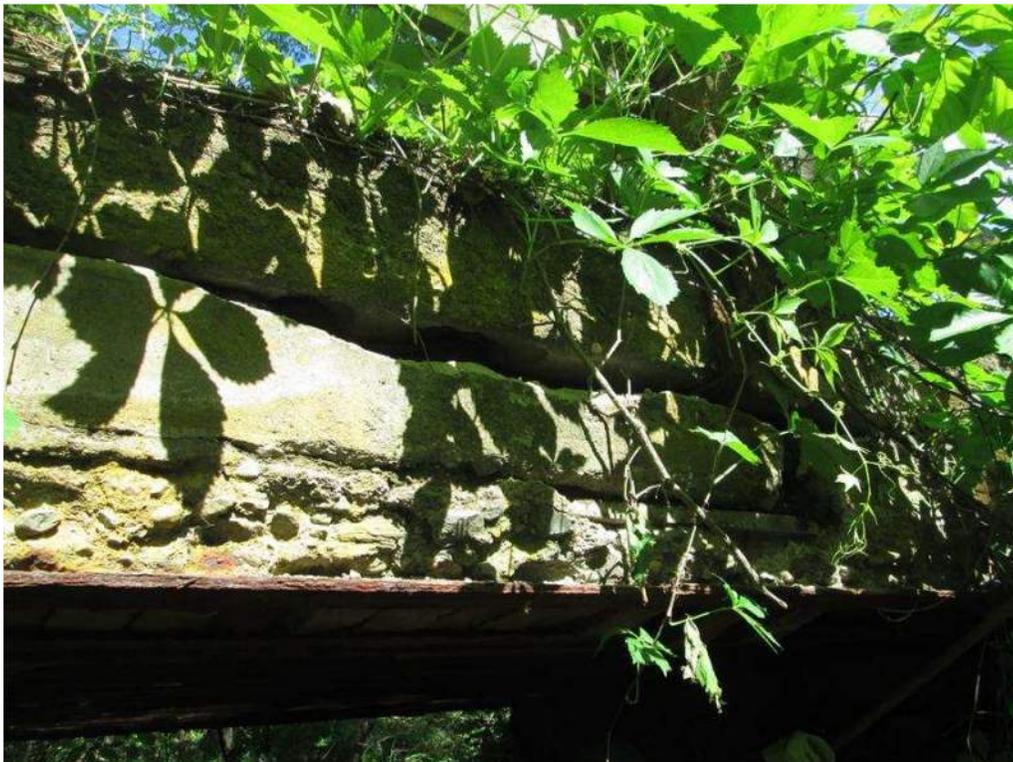
Photo 2: East Fascia Heavy Spalling

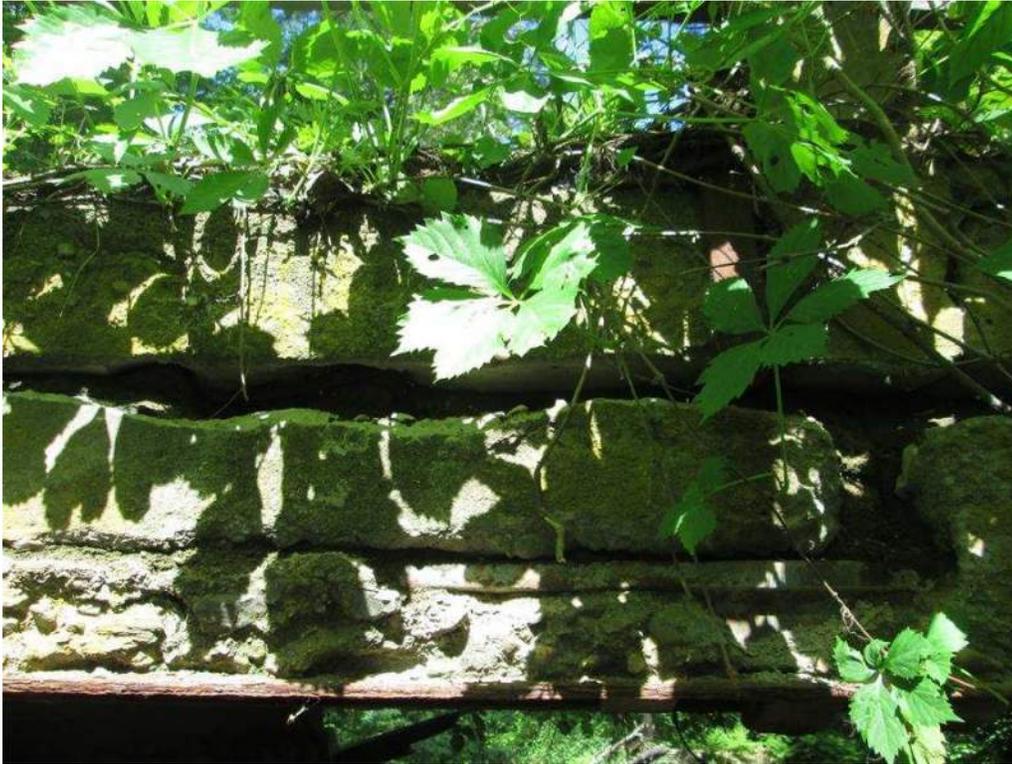
Photo 3: East Fascia Spalling with Exposed Outside Face of Rail R-20

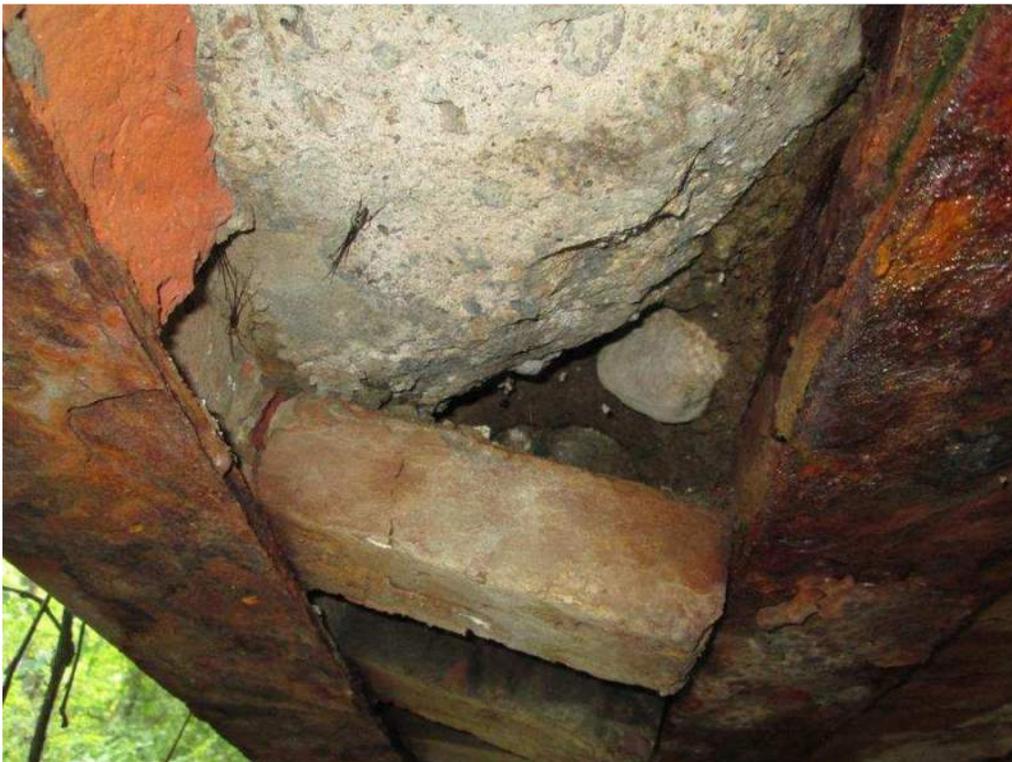
Photo 4: East Fascia Deck Underside Between Rails R-19 and R-20 Spall

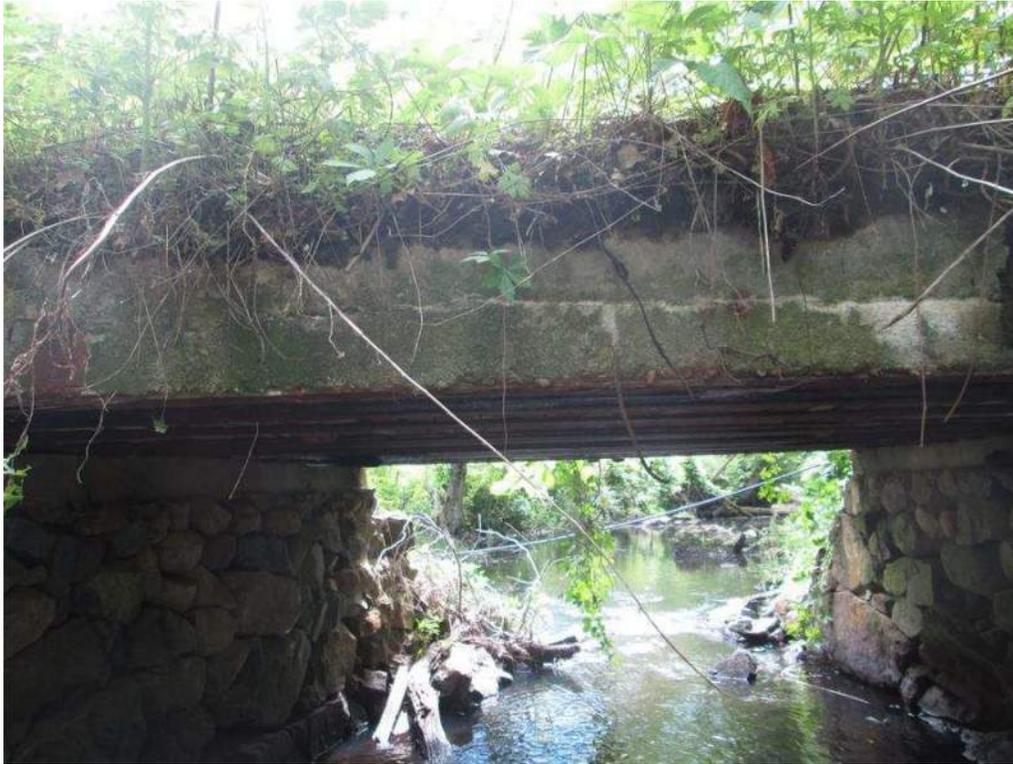
Photo 5: West Fascia Cold Joint Crack with Efflorescence and Rust Staining
